**REPUBLIC OF THE MARSHALL ISLANDS**  
Maritime Administrator

ANNUAL REPORT ON MARINE  
SAFETY INVESTIGATIONS  
2023

Published by: Republic of the Marshall Islands Maritime Administrator on 30 September 2024

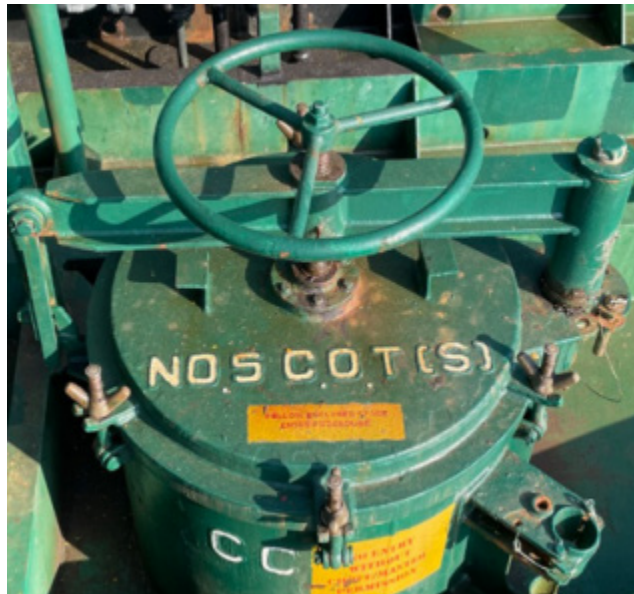
An RMI-registered oil / chemical tanker was in ballast condition awaiting voyage and cargo orders. The Deck crew were conducting maintenance on various Butterworth hatches on selected cargo tanks which, at the time, were inerted with  $N_2$ . During the morning maintenance, a plastic bucket fell inside the COT No. 5S and the Bosun entered COT No. 5S to retrieve it. A short time later, an ASD sighted the Bosun inside COT No. 5S and noted that he was unresponsive. The ASD raised the alarm before entering COT No. 5S to render assistance to the Bosun. The onboard rescue team found the Bosun and ASD unconscious inside COT No. 5S and commenced to retrieve first the Bosun and then the ASD. The Bosun survived, however, a short time after being rescued, the ASD was declared deceased. The Administrator's marine safety investigation determined the following:

- Unauthorized entry into an enclosed space was an unsafe act which could have been influenced by a state of hypoxia.
- The Company documented control measures existed but were not followed on board. This resulted in inadequate hazard identification of the risk of exposure to  $N_2$  and the danger of an  $O_2$  deficient environment.

- The Stop Work Authority procedure was not robustly implemented and therefore did not prevent unauthorized access to an enclosed space. For Stop Work Authority to be effective as a means of identifying and stopping an unsafe act or correcting an unsafe condition, all crewmembers must be confident that they can exercise it without recrimination.

Figure 1: Enclosed space entry location with warning.

- Necessary implementation and adherence to procedures combined with adequate oversight of maintenance and working routines should be sufficient in ensuring the safety of crewmembers undertaking the task required of them.

- Enclosed Space Rescue procedures must be properly practiced and drilled as if it were a real emergency. If crewmembers are not familiar with Enclosed Space Rescue procedures, they stand to put themselves and their fellow crewmembers in danger.

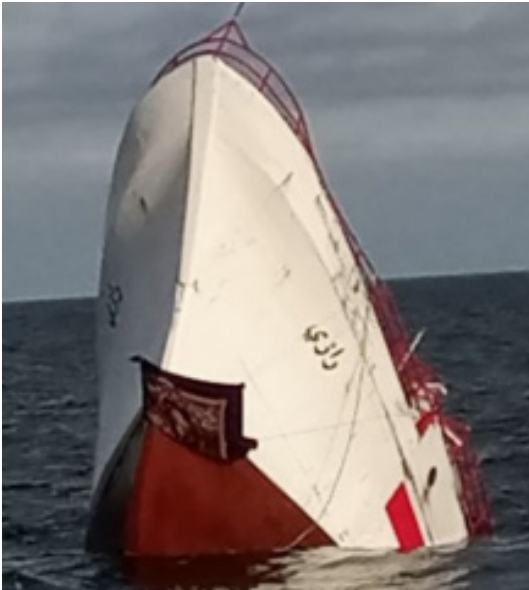
Figure 2: Moments prior to the sinking of the fishing vessel.

During the early morning hours, an RMI-registered bulk carrier encountered a large concentration of fishing vessels while underway in the Mediterranean Sea. The weather was good with visibility in excess of 5 NM. After passing through the concentration of fishing vessels, the bulk carrier encountered two additional fishing vessels. The OOW of the bulk carrier initially determined the ship would pass between the two fishing vessels. As the bulk carrier approached the second fishing vessel from the west, the fishing vessel commenced maneuvering sporadically. Upon seeing this, the OOW decided it was necessary to change course and ordered the Helmsman to make two successive 5° turns to port. A collision between the bulk carrier and the fishing vessel occurred a short time later. The fishing vessel's hull was damaged and began flooding. All 10 of the fishing vessel's crewmembers who had been on board were rescued before the vessel sank approximately three hours after the collision.

- The collision was the result of the ineffective application of navigation watchstanding principles on board the bulk carrier. The investigation also determined that the fishing vessel's Captain was not maintaining a safe navigational watch by concurrently conducting maneuvers to avoid collision and monitoring crewmembers' work on deck.
- The Administrator's investigation further determined that the white deck lights on board the fishing vessel interfered with the ability of the bulk carrier's bridge team to see the navigation lights that were exhibited by the fishing vessel.

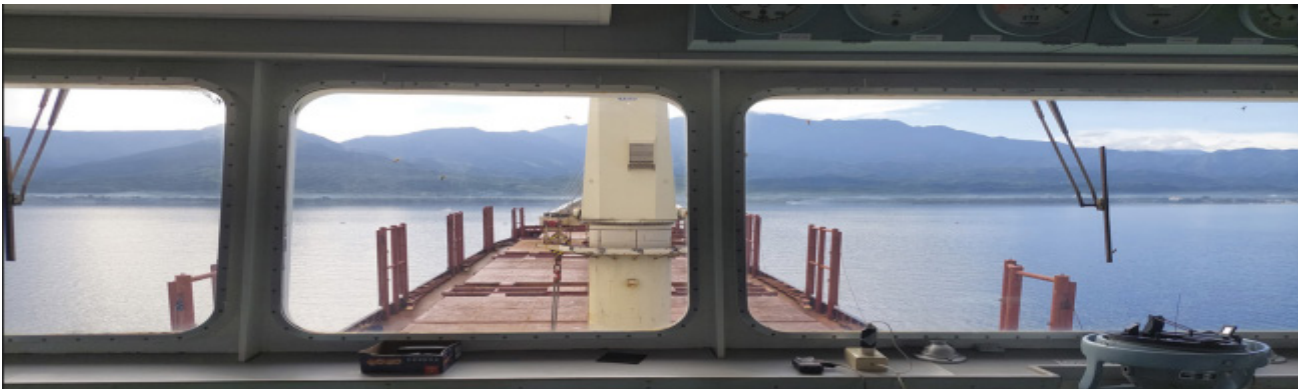
Figure 3: View from the center line of the Bridge from the bulk carrier.

- Neither vessel maintained an adequate lookout. Ineffective navigational watchkeeping standards on board both vessels resulted in inadequate application of COLREGs. Further, the bulk carrier failed to recognize the necessity to use all available means to maintain a proper lookout while navigating in an area known to contain small conspicuous vessels.

- Repeated deviation from Company documented procedures that required a lookout to be on duty was normalized on board.
- The radars on board the bulk carrier were not utilized as required by both Company procedures or with the provisions of COLREGs. One radar was deliberately placed in standby mode resulting in a reduction of detection and collision avoidance information. Simultaneously, the S-Band (3 GHz) radar was inadequately configured and set to 12 NM range scale, preventing the OOW the opportunity to identify small conspicuous vessels.

- The OOW on board the bulk carrier limited his athwartship movement across the Bridge, denying him the opportunity to see clearly ahead of the vessel.

- The OOW on board the bulk carrier was distracted by the frequent use of a cellular telephone during his watch in contravention of the Company's Bridge Watchkeeping Policies, Procedures and Performance Standards.

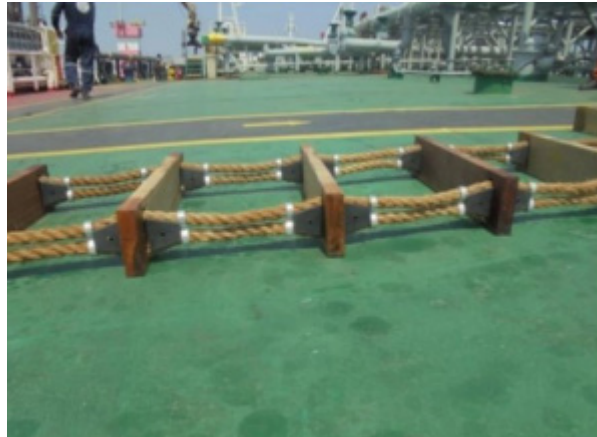
Late at night, an RMI-registered oil tanker, was anchored in an outer anchorage offshore awaiting orders. It was planned that two of the Company's Superintendents and three service technicians would embark while it was at anchor to repair one of the ship's anchor windlasses. Just after midnight, a tugboat arrived alongside and was made fast on the port side, in way of the pilot boarding station. The tugboat was reported to be rolling moderately after being made up alongside the ship. The first of the two Superintendents successfully embarked using the ship's accommodation ladder. Because the tug was rolling, the second Superintendent asked the ship's C/O, who was on deck supervising the transfer operation, to rig a combination pilot ladder. After the combination pilot ladder was rigged, the second Superintendent, who was wearing a backpack, successfully transferred from the tug to the pilot ladder and started climbing up. He stopped climbing and appeared to rest for a couple of seconds before falling 3.5-5 m onto the gunwale of the tug so that half of his body was inboard of the gunwale and the other half was over the side. Within minutes of the fall, the Superintendent had been brought on board the tug which then cast off to seek medical assistance.

Figure 4: Pilot ladder used to transfer personnel.

- A lack of Company policies regarding fatigue and medical requirements for the Company's shore staff who may need to embark a ship in the Company-managed fleet as part of their assigned duties.

- The procedures in the Company’s SMS for embarking and disembarking personnel from launches did not address carrying backpacks while climbing ladders.
- Lifejackets were not considered within the Company procedures prior to climbing up or proceeding down a pilot ladder.

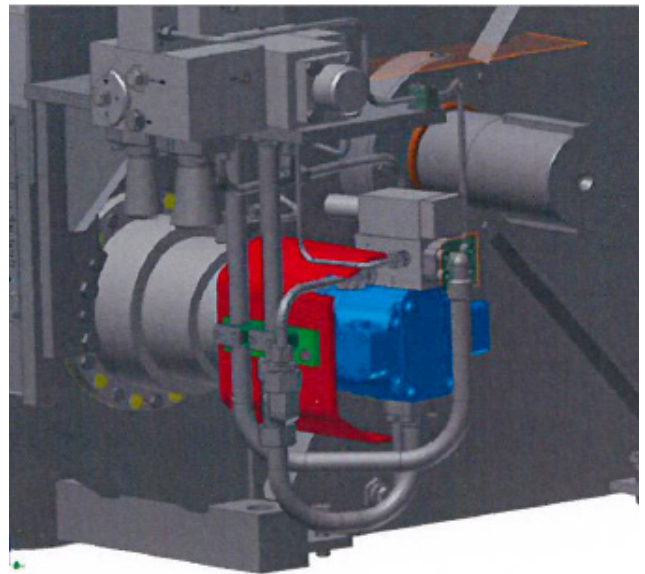
- That the movement of the ship in the existing sea conditions imposed dynamic loads on the anchor windlass and ground tackle that exceeded the combined brake capacity of the anchor windlass. This led to the parking brake slipping, followed by the unintended release of the anchor chain which resulted in the overspeed of the planetary gear and consequently a destroyed hydraulic motor.

- The windlass motor was not covered with a protection plate. The Bosun, who was standing in close proximity to the hydraulic windlass motor was struck by flying debris resulting in an open fracture with arterial bleeding.

Figure 5: An example of a protection cover over the windlass motor shown in red.

- Windlass motors have operating limitations and can fail. The operating limitations should be understood by the operating crew.
- A suitable protection system around the hydraulic motor offers protection to the operator in case of structural failure of the motor.

- General wear and tear can impact the holding capacity of the windlass. A periodical service by a recognized service station is recommended to improve holding capacity reliability.
