ECO GALAXY MARINE SAFETY INVESTIGATION REPORT

Occupational Fatality

Port Klang Pilot Station, Malaysia | 30 August 2023

Official Number: 6293

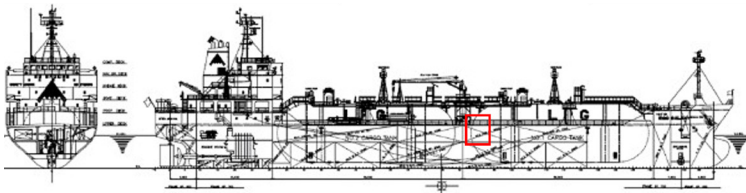
Figure 1: ECO GALAXY General Arrangement plan. The location of the starboard side pilot boarding area is shown in the red square.

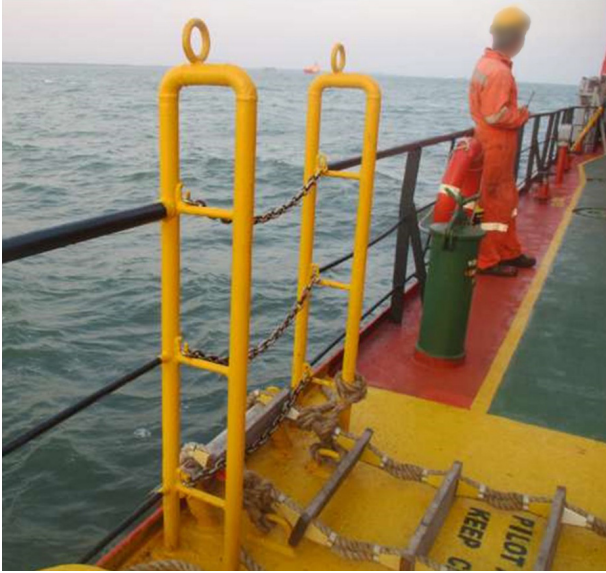
Figure 2: Starboard side pilot boarding area.

As the Pilot had informed the 3/O and the ASD1 that the pilot ladder could be kept in place, no handling was required other than closing the two removable chains (*see Figure 2*). Most probably, the ASD1 fell overboard while attempting to close the chains between the two upright stanchions but the reason for falling overboard could not be determined with certainty. It was possible that the ASD1 slipped on the wet deck despite the anti-skid paint or that he tripped over a part of the pilot ladder that was lying on deck or over a securing point on deck. As the activity of the ASD1 before falling overboard was not witnessed, it could not be excluded that he was checking or repairing a part of the pilot ladder over the ship's side and lost his balance.

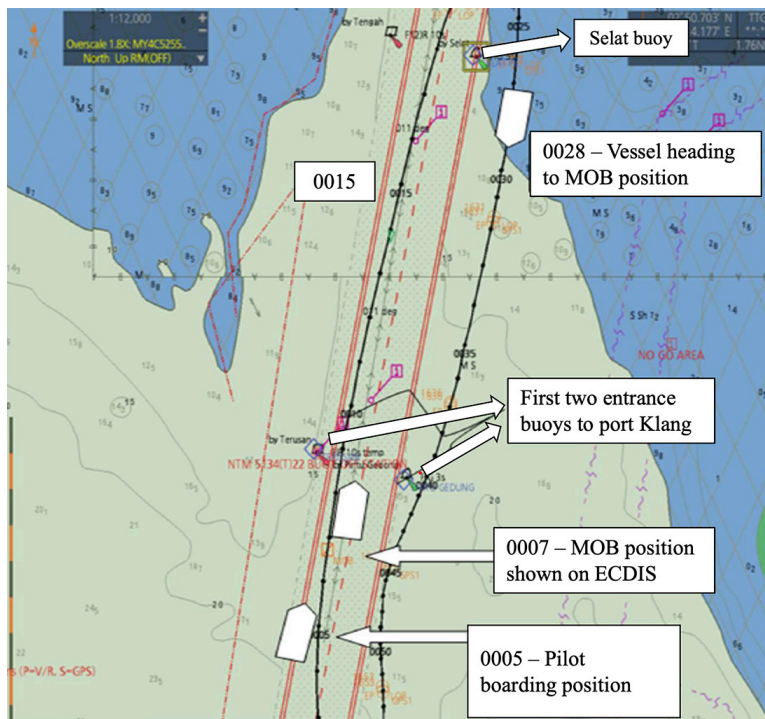
The 3/O assumed that it was the ASD1, based on the shouting he heard and as he could not locate the ASD1 on deck. The 3/O alerted the Bridge, by means of his hand-held radio, and ran toward the starboard quarter where he took a lifebuoy with line and threw it to the ASD1. He was not able to observe if the ASD1 could reach the lifebuoy. Meanwhile on the Bridge, the MOB position, 02°51.15'N, 101°15.22'E, was plotted on the ECDIS and the Master ordered all deck and search lights switched to the on position (see Figure 3).

Figure 3: Track of ECO GALAXY from anchorage.

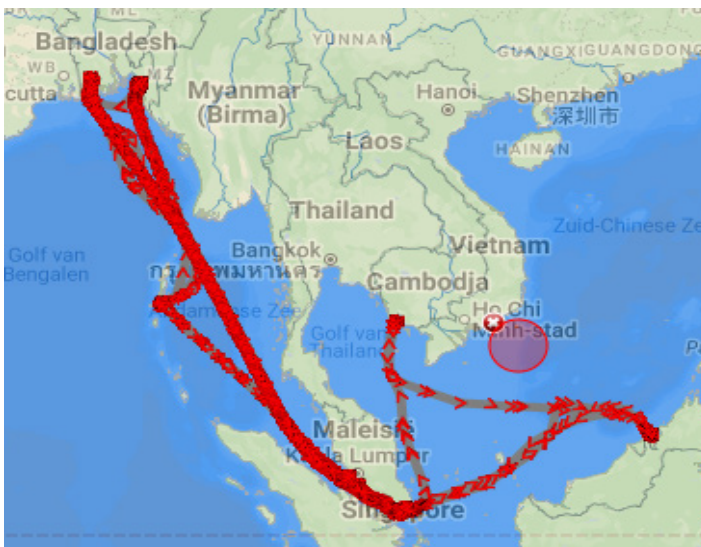
Between 30 August 2022 and 30 August 2023, ECO GALAXY had called Port Klang 27 times at regular intervals. In the same period, other ports in the South-East Asia region were frequently called as well (see Figure 4).

Figure 4: Voyages of ECO GALAXY between 30 August 2022 and 30 August 2023.

It can be concluded that Pilot transfers were frequently and regularly executed on board ECO GALAXY which could have led to risk normalization. Dangerous conditions can be perceived as normal over time and accepted practice and silent deviations from procedure may arise.¹²
