PORTHOS AND ZHE FENG YU 1302 MARINE SAFETY INVESTIGATION REPORT

Collision

East China Sea | 16 December 2022

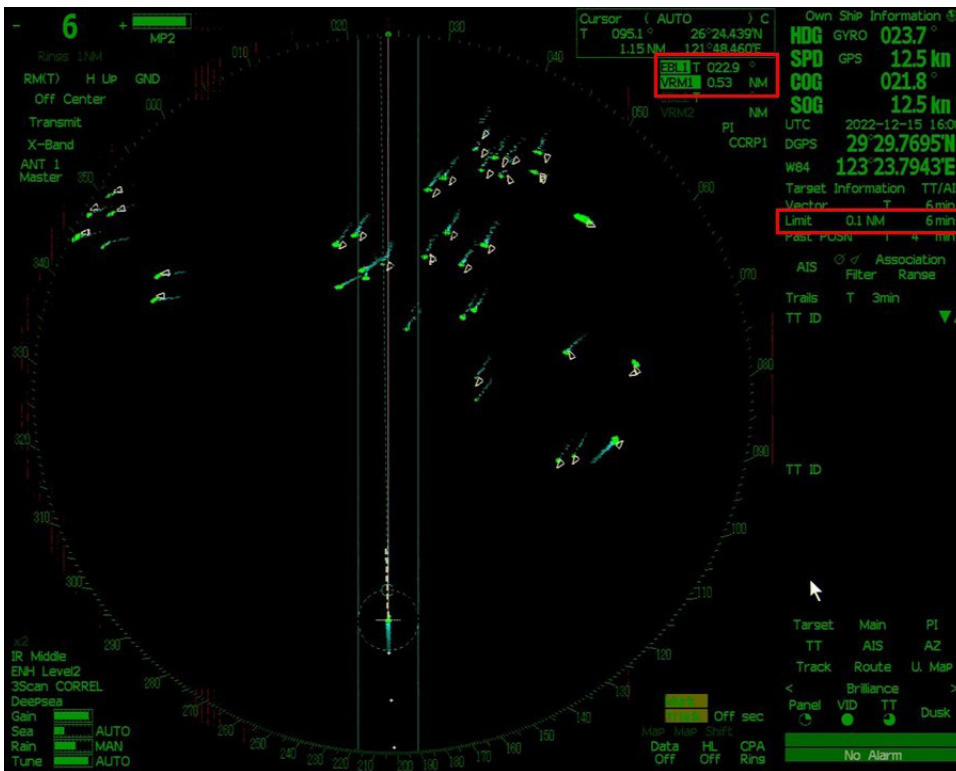
The 2/O stated that AIS information was displayed on the X-Band radar⁵ and the two ECDIS units. The 2/O also reported that the ARPA was set for manual target acquisition and that the CPA limit was set to 1 NM but that neither the visual nor audible alerts for the ARPA on the X-Band radar and the S-Band radar were enabled. Based on the images recorded by PORTHOS' VDR when the 2/O relieved the 3/O as the OOW at midnight, the X-Band radar was on the 6 NM scale with the relative motion display with "own ship offset" selected. The CPA limit was set at 0.1 NM, the TCPA was set at 6 minutes, EBL1 was at 022.9° T, and VRM1 was at 0.53 NM (see Figure 3).⁶

Figure 3: Image of PORTHOS' X-Band radar at midnight on 16 December 2022. The settings of the CPA and TCPA limits, EBL1, and VRM1 are highlighted in red.

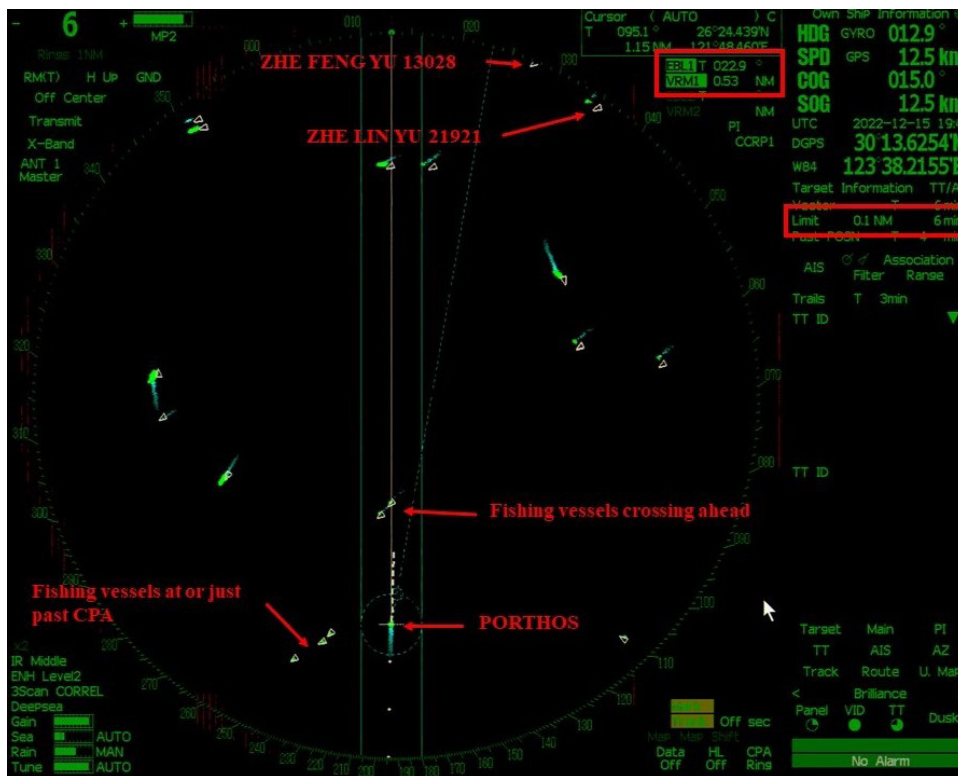
At approximately 0340, the 2/O started turning PORTHOS from 015° T to the next planned course of 357° T. At the time, there were three fishing vessels passing down the ship's port side with a CPA of 0.75-1 NM and two other fishing vessels crossing ahead of the ship at a range of approximately 1.5 NM.⁸ At the same time, ZHE FENG YU 13028 and ZHE LIN YU 21921 were becoming visible on the ship's radar at approximately 7 NM off the ship's starboard bow (see Figure 4). All of the fishing vessels were on a west southwesterly heading.

Figure 4: PORTHOS' X-Band radar at 0340. Note that the settings of the CPA and TCPA limits, EBL1, and VRM1 (marked in red) were the same as when the 2/O assumed the watch at midnight.

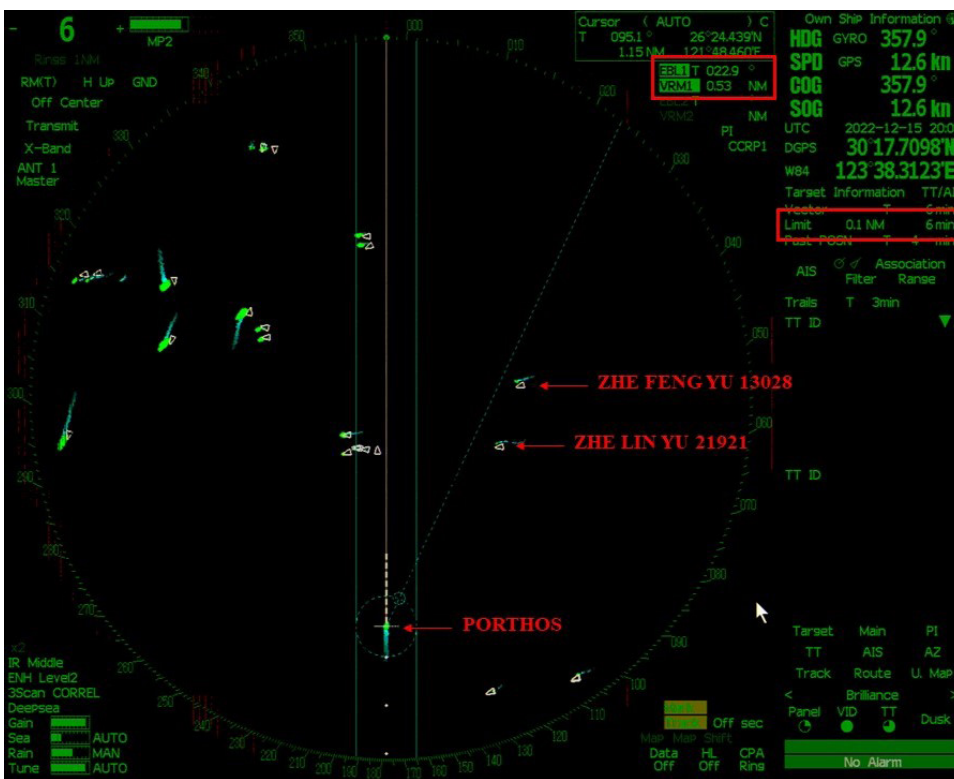
Figure 5: Image of PORTHOS' X-Band radar at 0400. Note that the settings for the CPA alarm, EBL1, and VRMI (marked in red) are the same as they were when the 2/O went on watch at midnight.

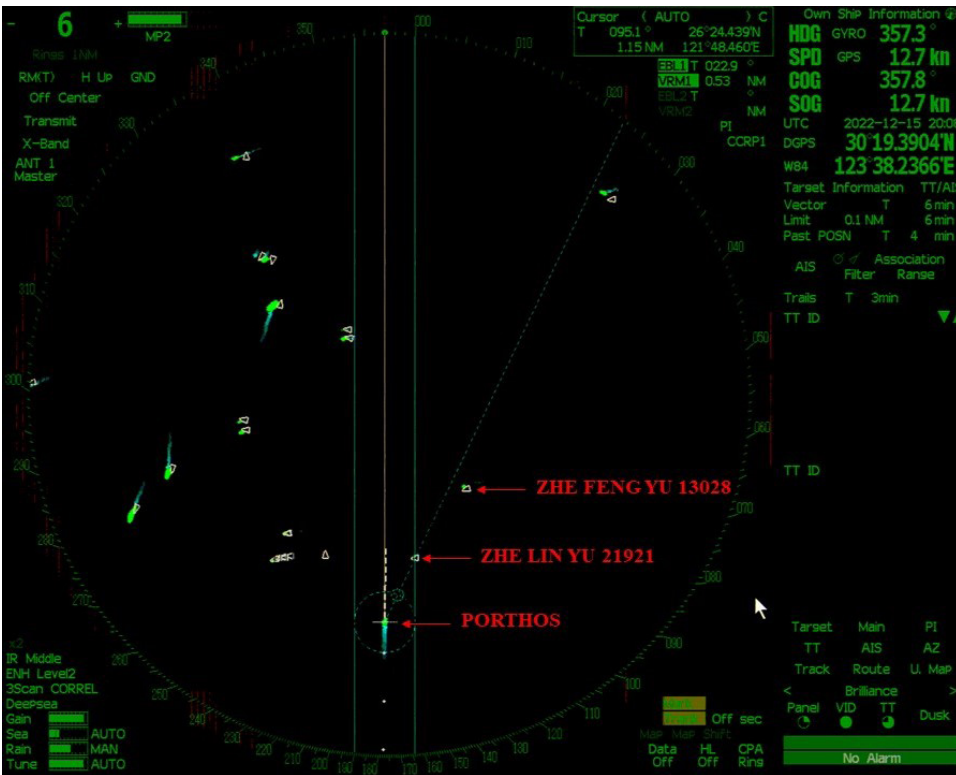
Figure 6: Image of PORTHOS' X-Band radar at 0408.

At 0410, ZHE LIN YU 21921 was crossing ahead of PORTHOS' bow at a range of approximately 0.6–0.7 NM and ZHE FENG YU 13028 was 1–1.2 NM off the ship's starboard bow at approximately the same bearing as it had been at 0400 and 0408. By this time, PORTHOS, whose heading had reached 007° T, started turning back to port (see Figure 6). The C/O stated he had not intended to turn back to port and that it was caused by the autopilot turning the ship back to the set course (357° T). The ship continued turning to port for almost 1.5 minutes before the C/O again used the autopilot to turn the ship back to starboard.

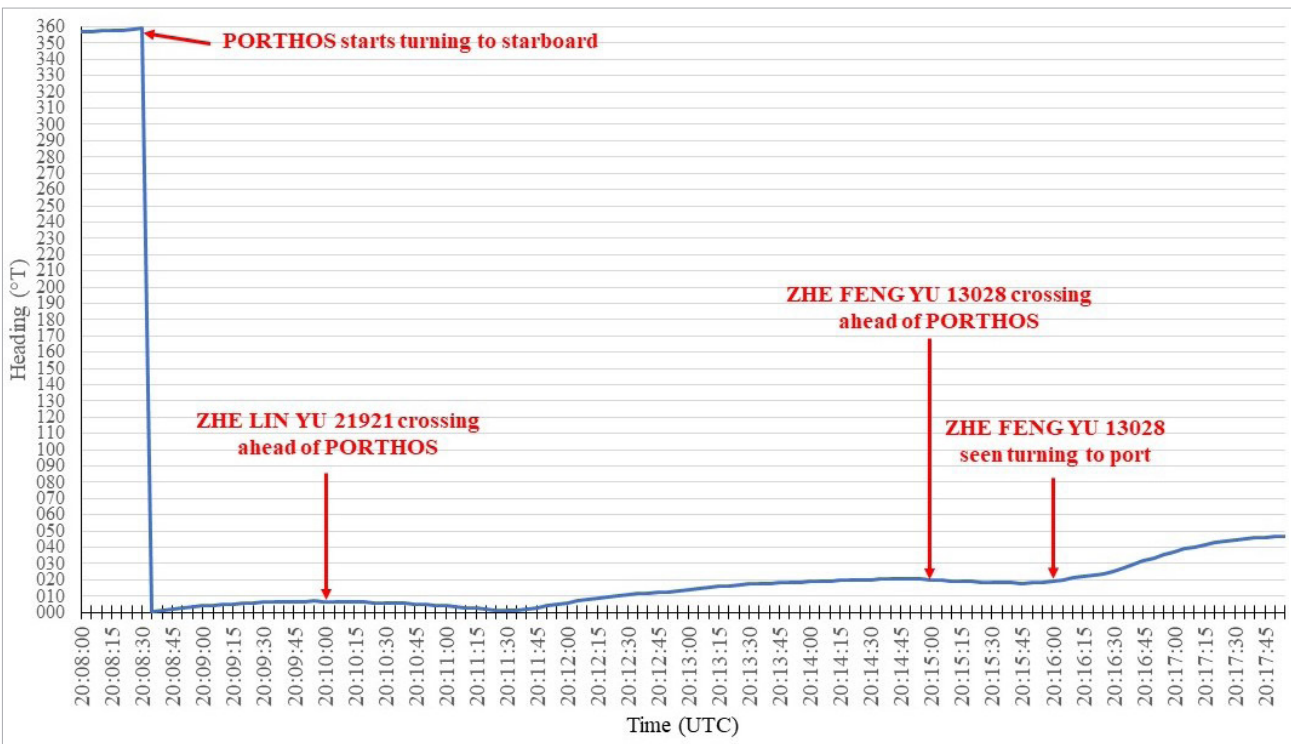
Figure 7: Plot of PORTHOS' heading from 0408–0418 as ZHE LIN YU 21921 and ZHE FENG YU 13028 crossed ahead of the ship's bow.

At 0416, there was a second automated message addressed to a ship whose call sign included V, R, and J. The contents of this message were similar to the content of the message that was heard at 0413. The bearing from the vessel to which the message was addressed could not be heard because the C/O was yelling. The range included in the message was 0.4 NM. The C/O stated he saw ZHE FENG YU 13028 turn to port toward PORTHOS' bow (*see Figure 8*) as this message was being received. He also reported that he lost sight of the fishing vessel after seeing it turn to port and that he then sounded one short blast of the ship's whistle, which can be heard on the Bridge audio recorded by PORTHOS' VDR. The C/O then ran out on the starboard bridge wing. PORTHOS continued to turn to starboard as this occurred (*see Figure 7*).

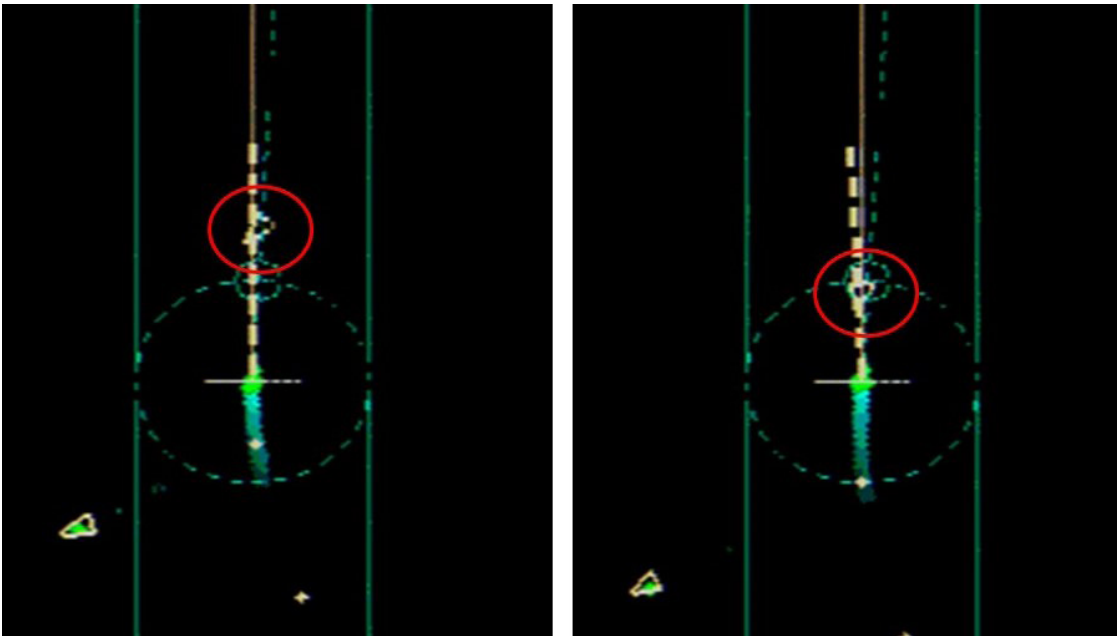
Figure 8: Images of PORTHOS' X-Band radar at 0415 (on left) and 0416 (on right) as the ship was turning to starboard. The radar display was set to relative motion. ZHE FENG YU 13028's turn to port as PORTHOS was turning to starboard is shown by the change of orientation of the AIS contact (circled in red). The AIS contact of PORTHOS' port quarter is ZHE LIN YU 21921.

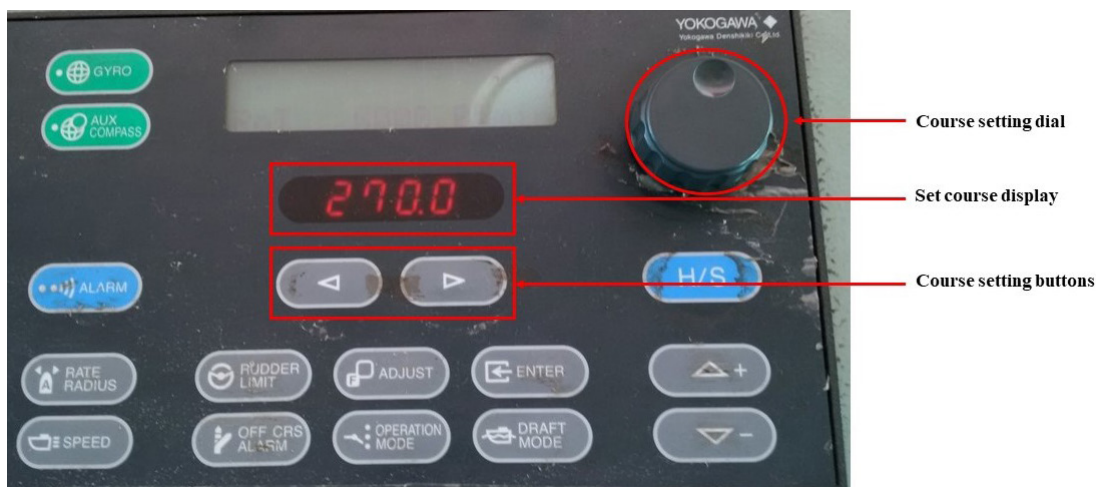
PORTHOS was equipped with a Yokogawa Denshikiki Co. Ltd. PB343 auto steering unit (or autopilot) (see Figure 9). The autopilot was located on the console directly forward of the ship's wheel. Based on the user's manual for PORTHOS' autopilot, the set course could be changed while the autopilot was engaged by:

Figure 9: The autopilot on board PORTHOS showing the course setting dial, set course display, and the course setting buttons. The ship could be turned to port or starboard by turning the course setting dial to either the left or right or by pressing the left or right arrow course setting button.

The C/O's use of the autopilot rather than changing to hand steering to maneuver PORTHOS as a close quarters situation was developing with both ZHE LIN YU 21921 and ZHE FENG YU 13028 was not consistent with the guidance in the Company's SMS regarding the use of the autopilot or the principles for navigational watches in the STCW Code. These principles require that OOWs take into account the need "to station a person to steer the ship and to put the steering into manual control in good time to allow any potentially hazardous situation to be dealt with in a safe manner."²¹
